# GulfSea SDA Insights

## Scavenge Port Inspection Guidelines

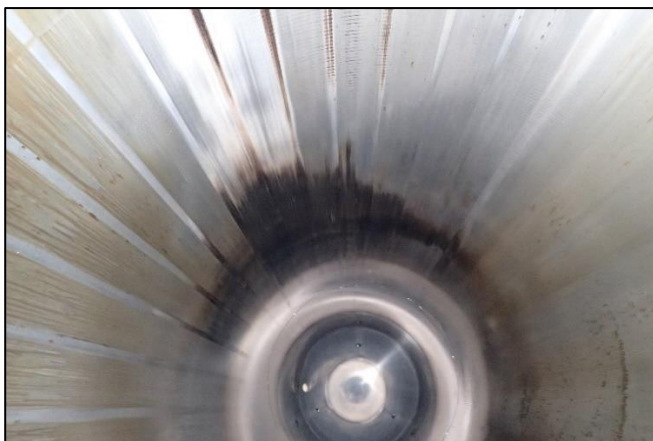
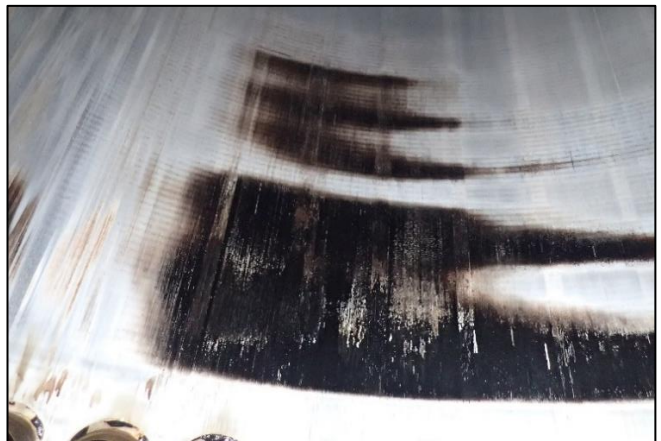
Cold Corrosion is a common phenomenon occurring in many modern 2-stroke marine engines. The compliance of IMO Tier II NOx regulations and Energy Efficiency Design Index (EEDI) guidelines has resulted in increased pressure and lower operating temperatures within the engine cylinders. The operating temperatures can be lower than the water dew-point causing moisture to condense on the cylinder liner walls which combined with the sulphur during the combustion process causes sulphuric acid to form. The acid causes corrosion of the cylinder liner material, creating excessive wear.

Cold Corrosion occurring on cylinder liners

If Cold Corrosion is observed in any of the cylinders it is recommended that the feed-rate for the affected unit(s) is increased and the liner condition monitored at the earliest opportunity. If the problem persists continue increasing the feed-rate until the condition improves. Depending on the sulphur content of the fuel in use it may be required to change a higher BN cylinder lubricating oil.

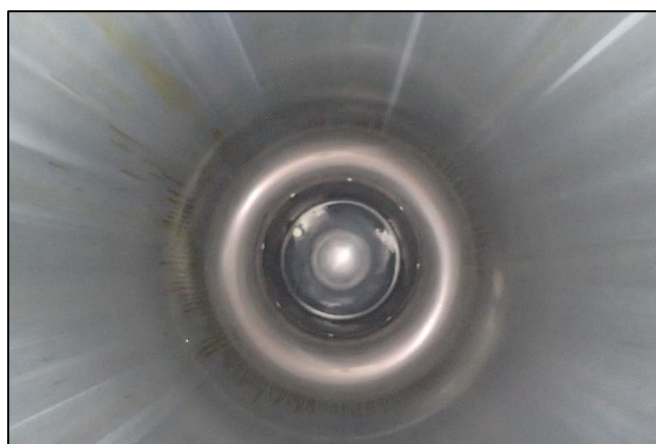
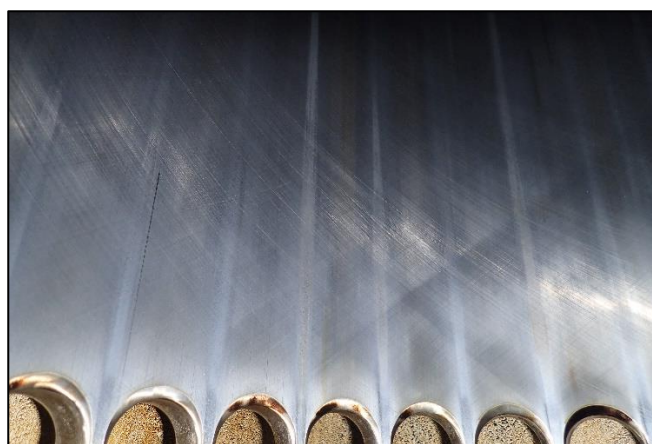
The pictures above show a cylinder liner without cold corrosion with the honing marks still visible

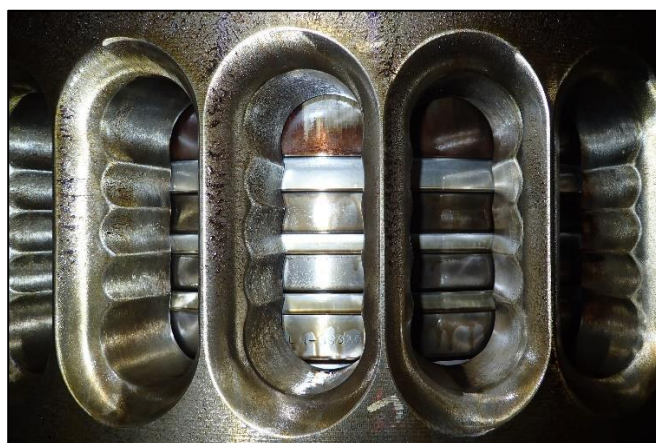
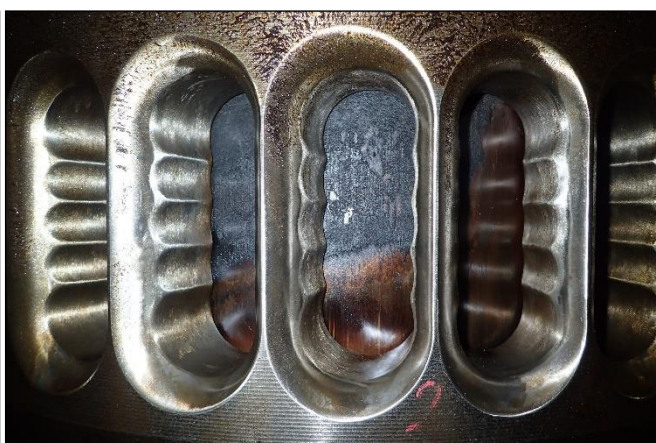
Left picture shows the piston rings with sufficient lubrication; the picture on the right shows the condition of the piston crown side with minimal carbon deposits.

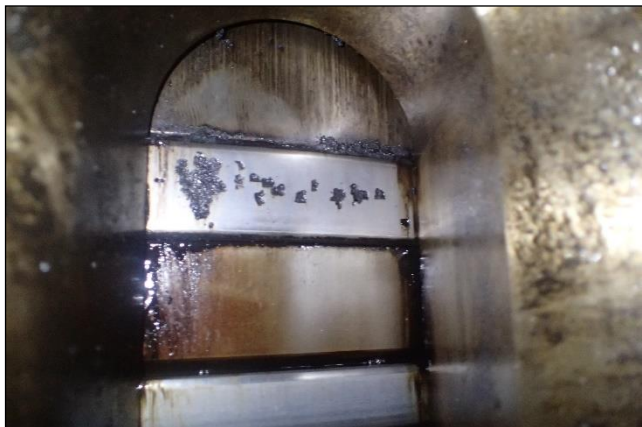
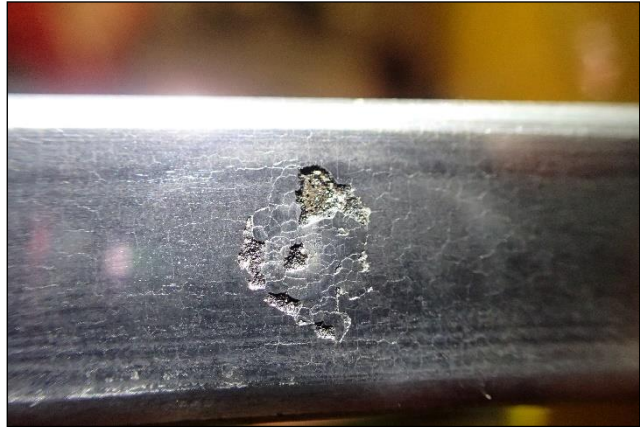
The pictures above show flaking/peeling of piston ring coatings

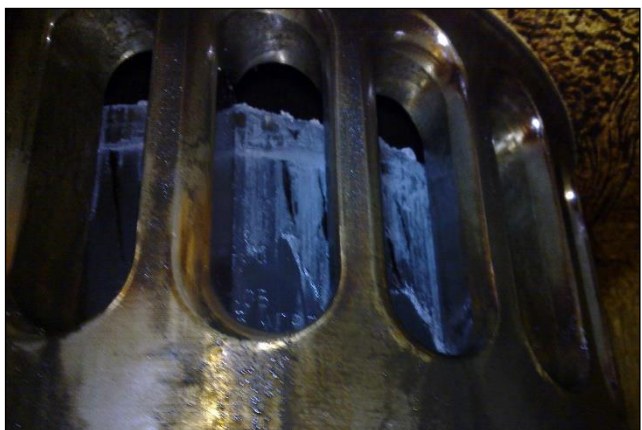
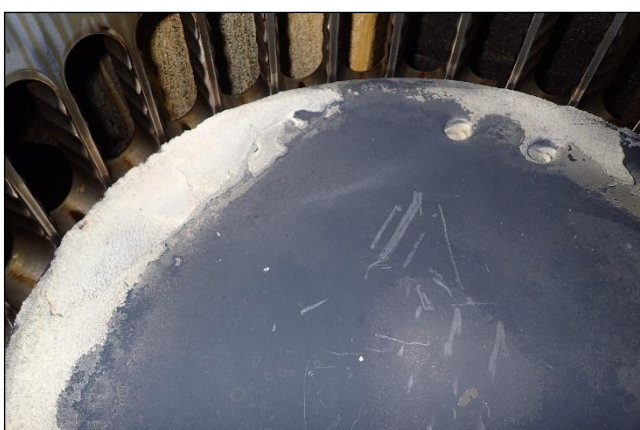
Under normal operating conditions the cylinder oil feed rates should be adjusted in accordance with manufacturer's recommendations. High or excessive cylinder oil feed rates lead to excessive alkalinity (BN) which will cause calcium carbonate to form. This might result in scuffing on the cylinder liners.

The pictures above show the effects on piston crown due to high cylinder oil feed rate; the white substances shown on the right are calcium carbonate deposits.

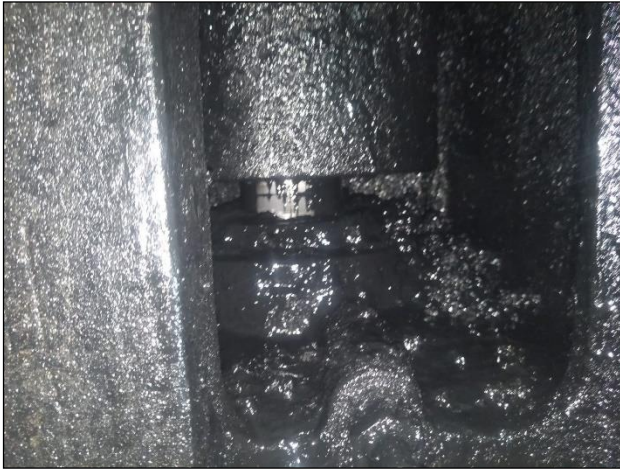
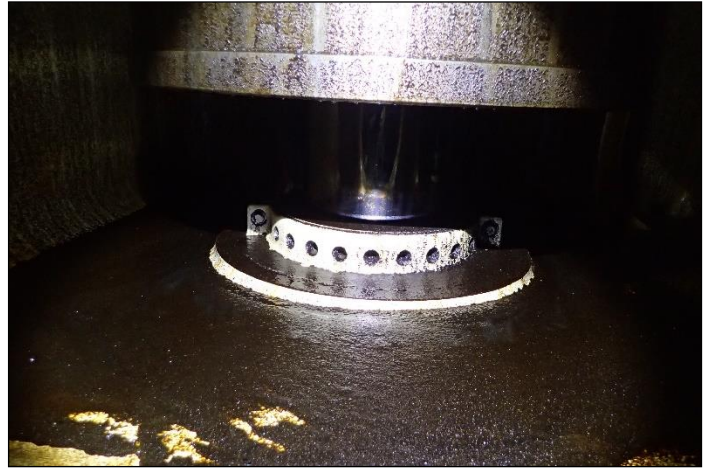
The left picture shows bad fuel quality and excessive “blowby”; the picture on the right shows “normal” running condition of the engine
